# La Salle Park Shoreline Erosion Abatement

F.J.Reinders and  
Associates Limited

September 1979

We are pleased to submit our final report on the  
LaSalle Park Shoreline Erosion Abatement Study.

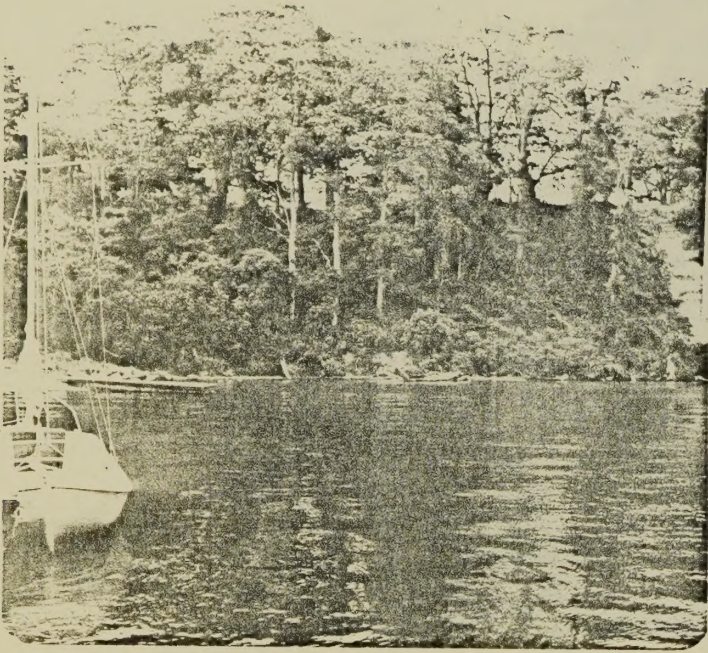
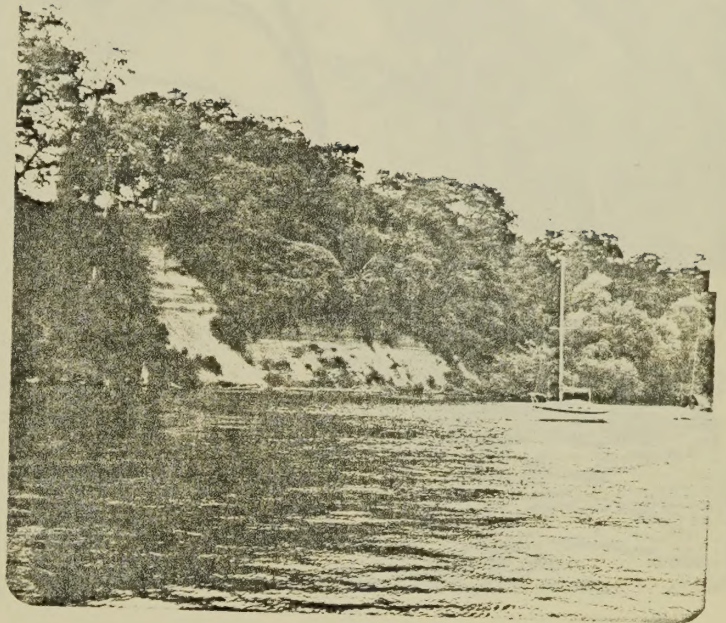
PHOTOS 1 - 4  
( WEST AND EAST END OF EXISTING SHORELINE )

The elevation difference ( $\pm$  15 metres) (50 feet) between the park and the water level of the Hamilton Harbour, and the erodible properties of the shore soils causes high steep bluffs to exist at the west and east ends of the park's waterfront (see Photos 1, 2, 3 and 4).

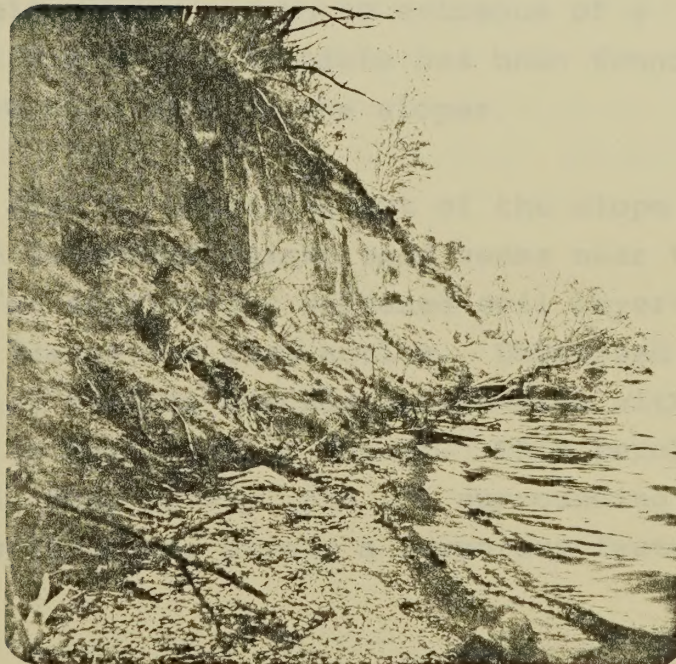
PHOTOS 9 - 10  
(EXISTING BLUFF SLOUGHING)

LaSalle Park consists of fields and bush on hills of sand. Along the shore, two steep  $\pm$  14 metres ( $\pm$  45 feet) bluffs dip sharply towards the bay. Some slope instability can be seen as sections of the bluffs have sloughed away recently (see Photos 9 and 10).
